Development of a Lightweight Truck Mounted Attenuator July 1983

California Department of Transportation

Final Report

Federal Research Grant No. D-4-163

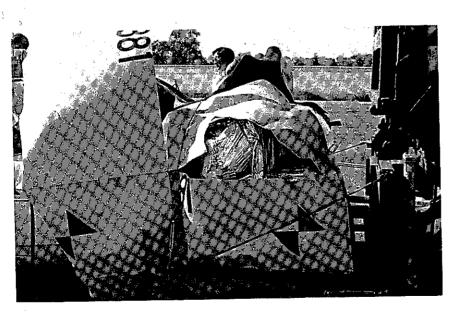
TMA Crushed About Six Feet No Damage to Truck or TMA Hardware

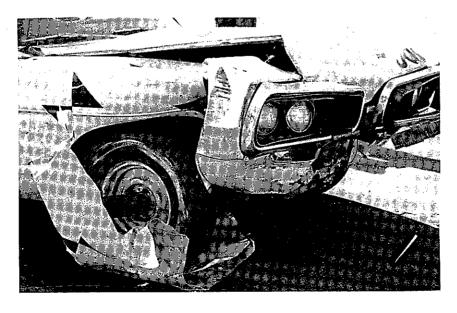
Test Car Damage

Car Damage - 381: Damage to the car was severe but less than test 371. The front end was uniformly crushed back 10 inches. All four doors were opened easily. The radiator was moved back to the fan. The engine position was not changed. All damage was confined to the front fenders and hood area. There was no intrusion or damage inside the car. The windshield was intact. The car required towing from the impact location.

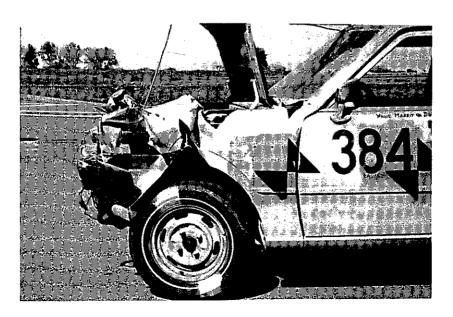
Car Damage - 384: Damage to the front of the car was severe. All front end components were crushed. The radiator was crushed back to the fan. The engine position was unchanged. Doors were not jammed and door posts were not damaged. The roof over the door post was not crimped as it was in Test 383. There was no interior damage. The windshield was intact. All tires were still inflated. The car was towed from the impact location.

Car Crush was 14-Inches

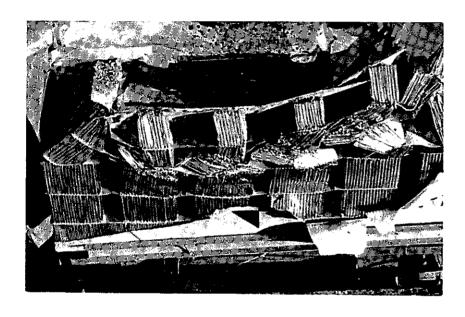
TMA Damage

Car Penetrated TMA 52-Inches

TMA Damage - 385: Sixty percent of the honeycomb cells were damaged during the impact. The car penetrated a 60-inch width of the 92-inch wide of the TMA on center line. The penetration of the car was 52-inches into the TMA. The undercarriage was undamaged.

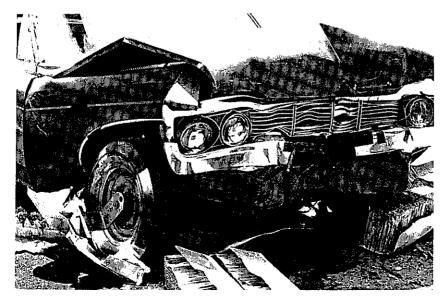
TMA Crushed 64-Inches

TMA Damage - 387: Seventy-five percent of the honeycomb cells were damaged during the impact. The redesigned lightweight support hardware was not damaged. The raise lower mechanism was not damaged.

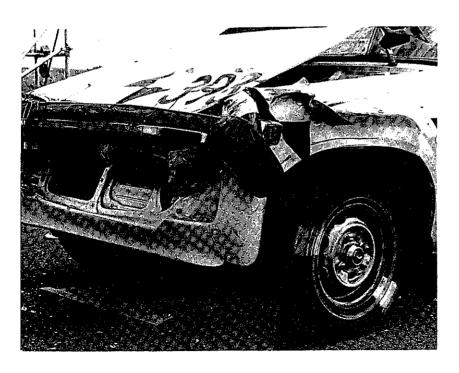
FIGURE 50

Front of Car Damage
